Terra Mission Operations: Launch to the present (and beyond)

Session 5: Earth Observing System (EOS) Terra I

Reference: SPIE Paper Number: 9218-21

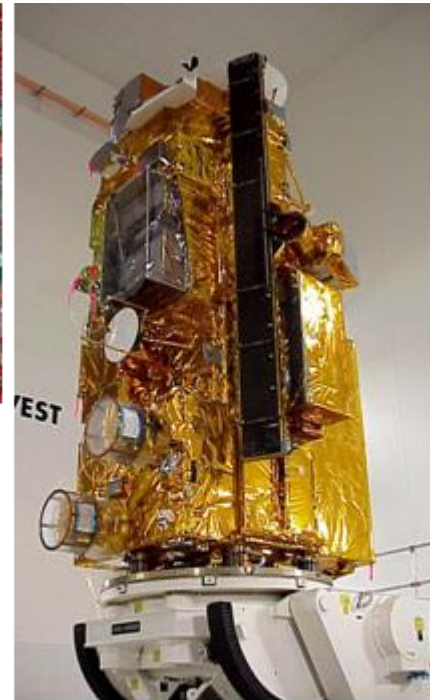
Terra (EOS AM-1)

CERES

MODIS

MISR

MOPITT

- **ASTER (SWIR, TIR & VNIR)** - Advanced Spaceborne Thermal Emission and Reflection Radiometer (Japan)
 - **CERES (Fore & Aft)** - Clouds and the Earth's Radiant Energy System (USA – Langley)

- **MISR** - Multi-angle Imaging Spectro-Radiometer (USA – JPL)
 - **MODIS** - Moderate Resolution Imaging Spectro-radiometer (USA – GSFC)
 - **MOPITT** - Measurement of Pollution in the Troposphere (Canada)
